# A Report on the Rhode Island Hall Well Survey

By: Kaitlin S. Deslatte, M.A.

Joukowsky Institute for Archaeology and the Ancient World

December 2008

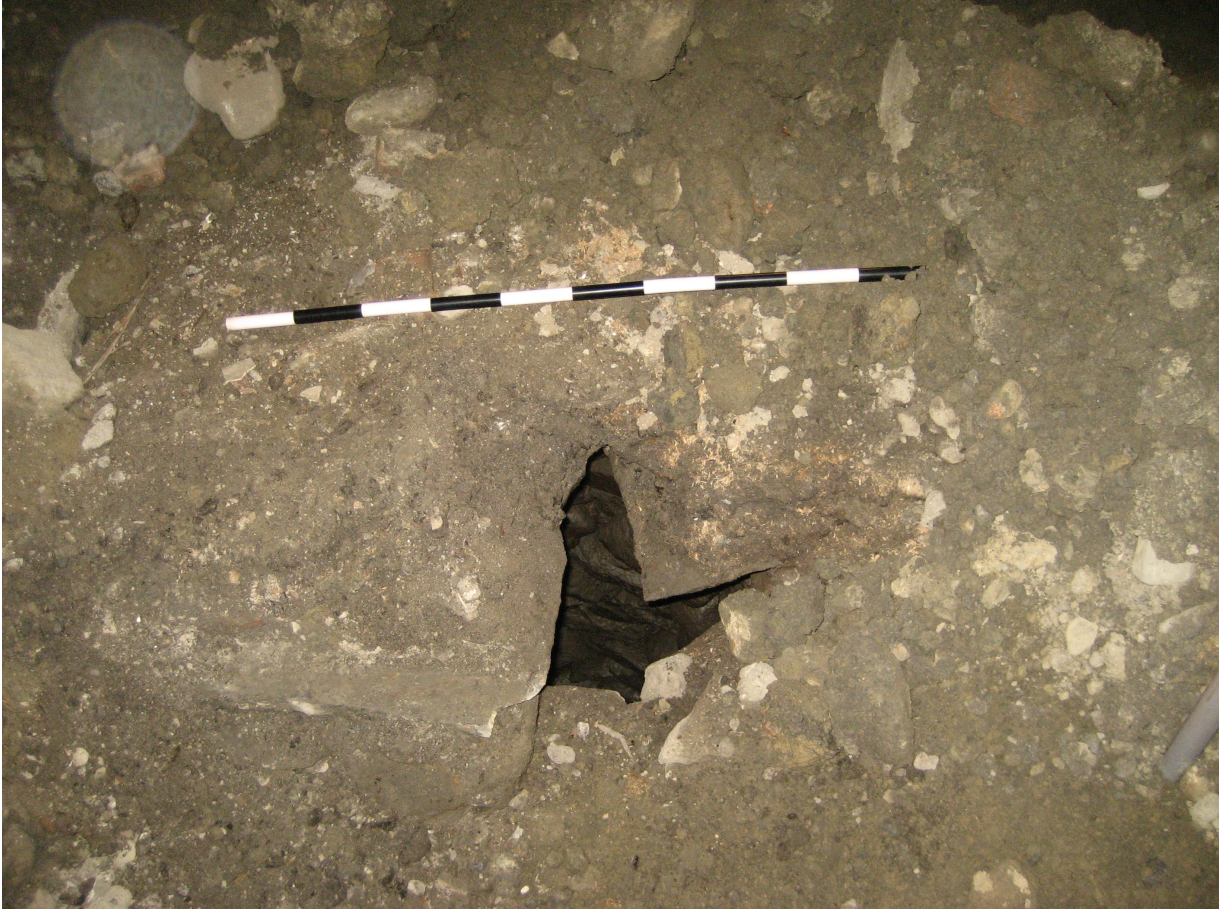
Working from the exposed southeast corner, uncovering the stone well was relatively easy. With the generous help of the construction crew and their excavation machines, the majority soil was quickly removed from around the well. Approximately 10cm of soil was left on the feature for careful hand excavation (See Figure 2). With shovel and trowel, the remaining

soil was removed from the well for full exposure. During this trowel process, approximately 5cm/2” of mortar was noted lying on top of the stone caps and can be seen in Figure 2 underneath the photographic scale bar, which is in 10cm increments.

Figure 2. North facing view of the well feature before initiating the survey.

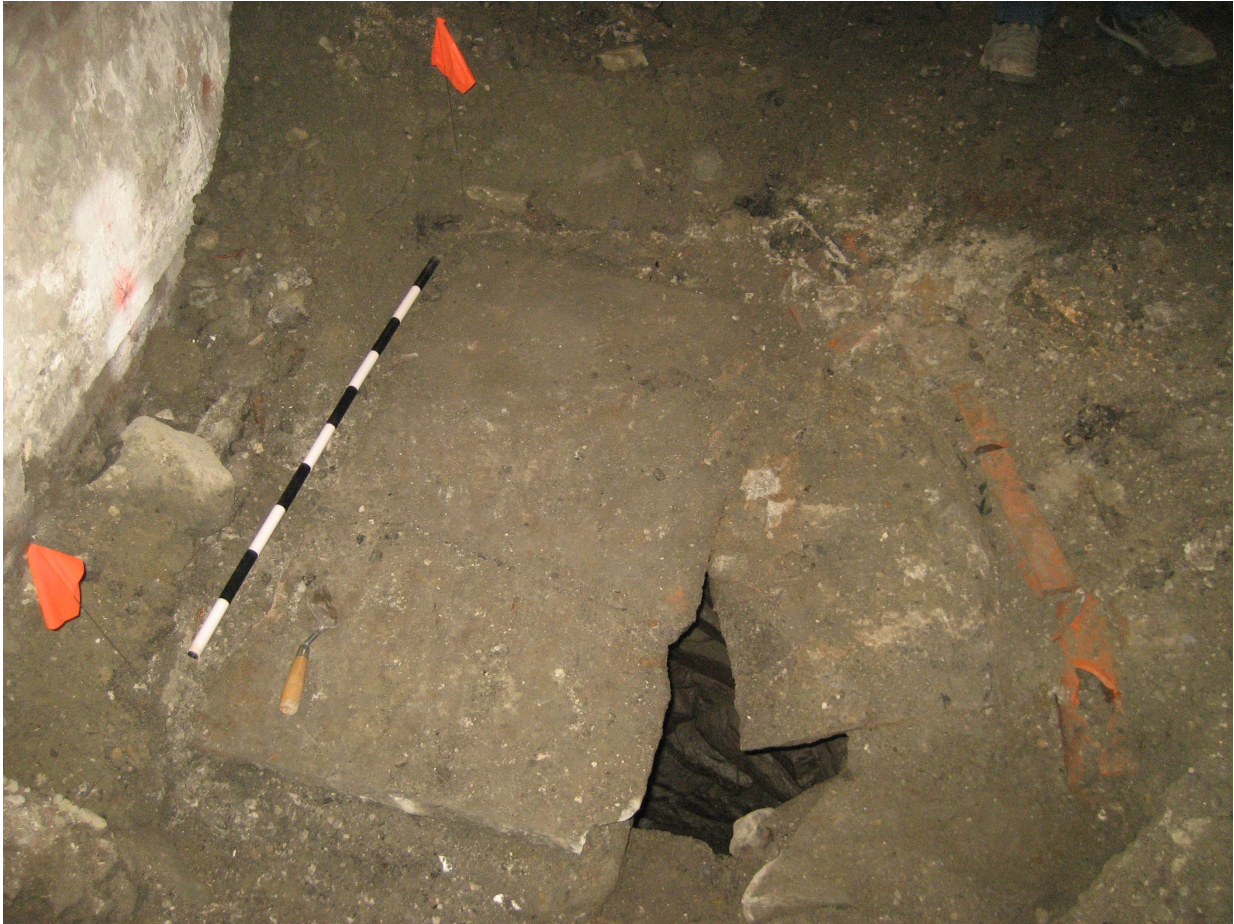
Once the soil was completely removed, the stone caps for the well appeared, in addition to a red terracotta drainage pipe system just to the east of the well. Hand drawn maps and several photographs were taken of these two features (See Figure 3 and Figure 4).

Figure 3. The exposed stone well cap (center) and terracotta drainage pipe system (right).

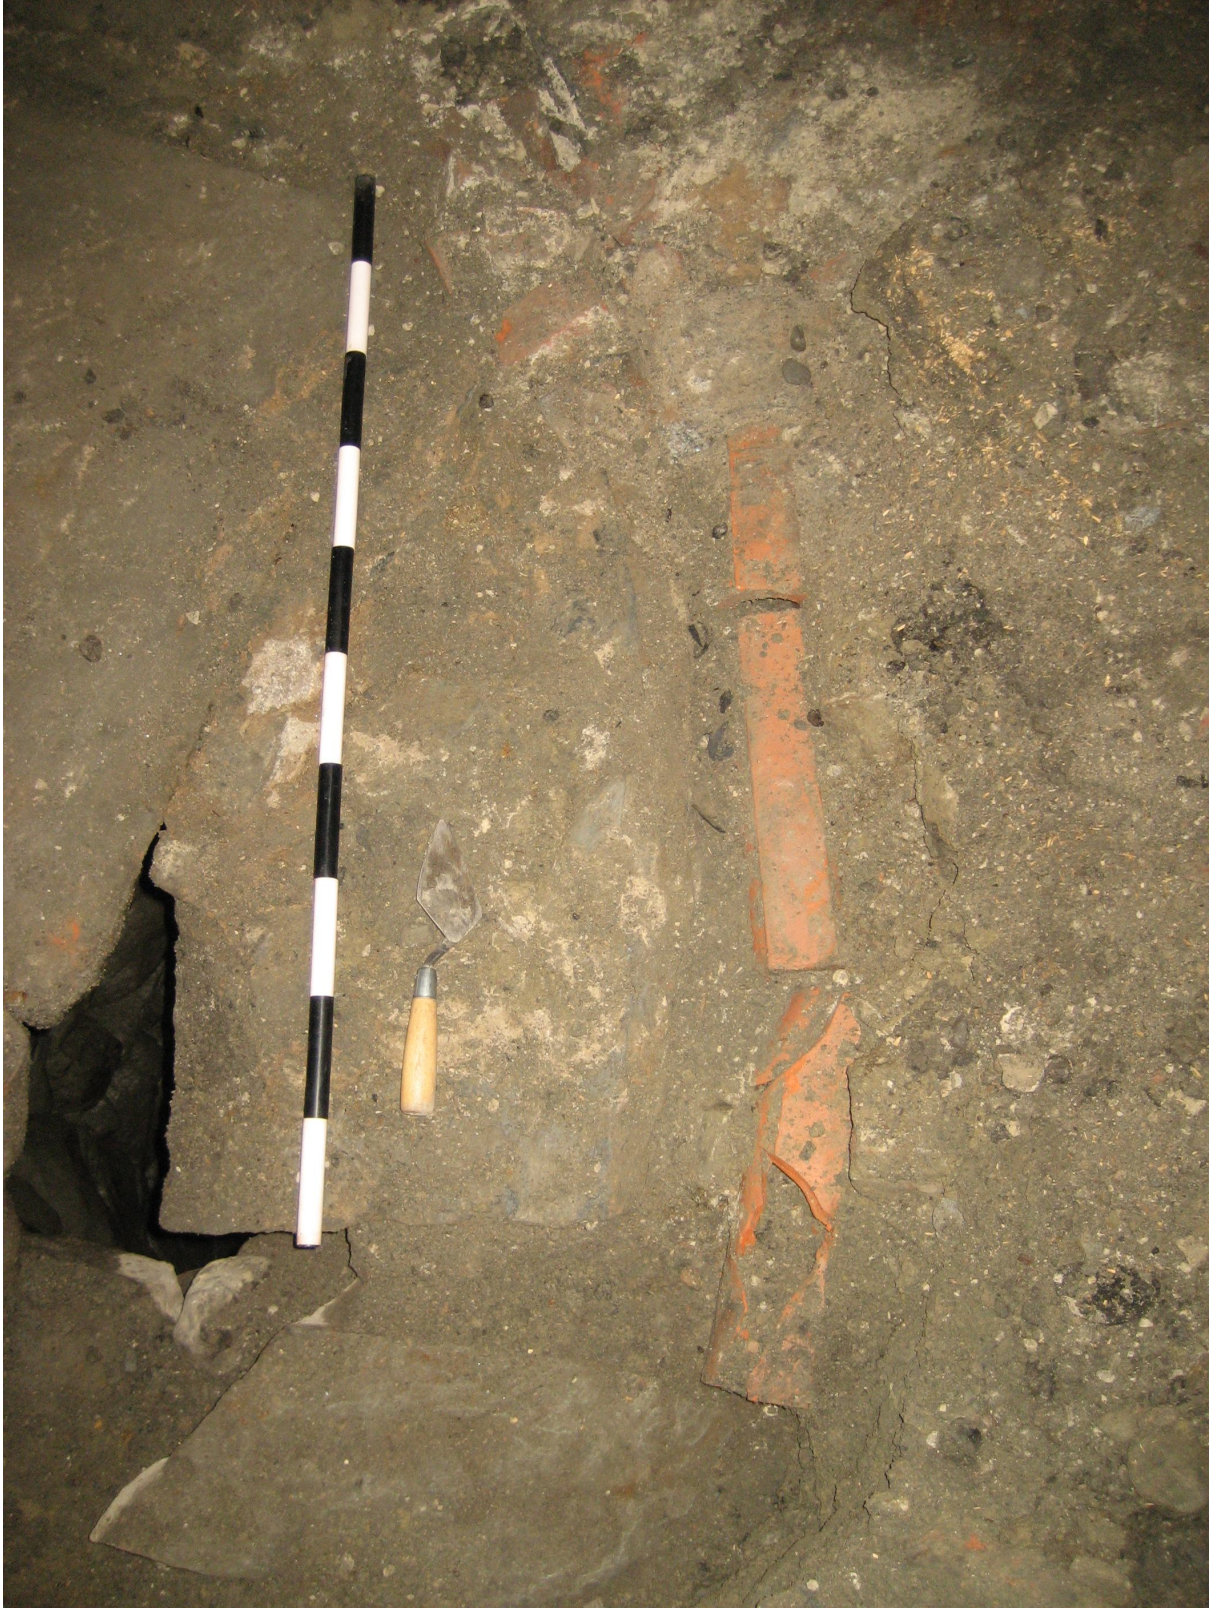
Figure 5. View of the terracotta drainage pipe system. Note the brick supports for the pipe (top center).

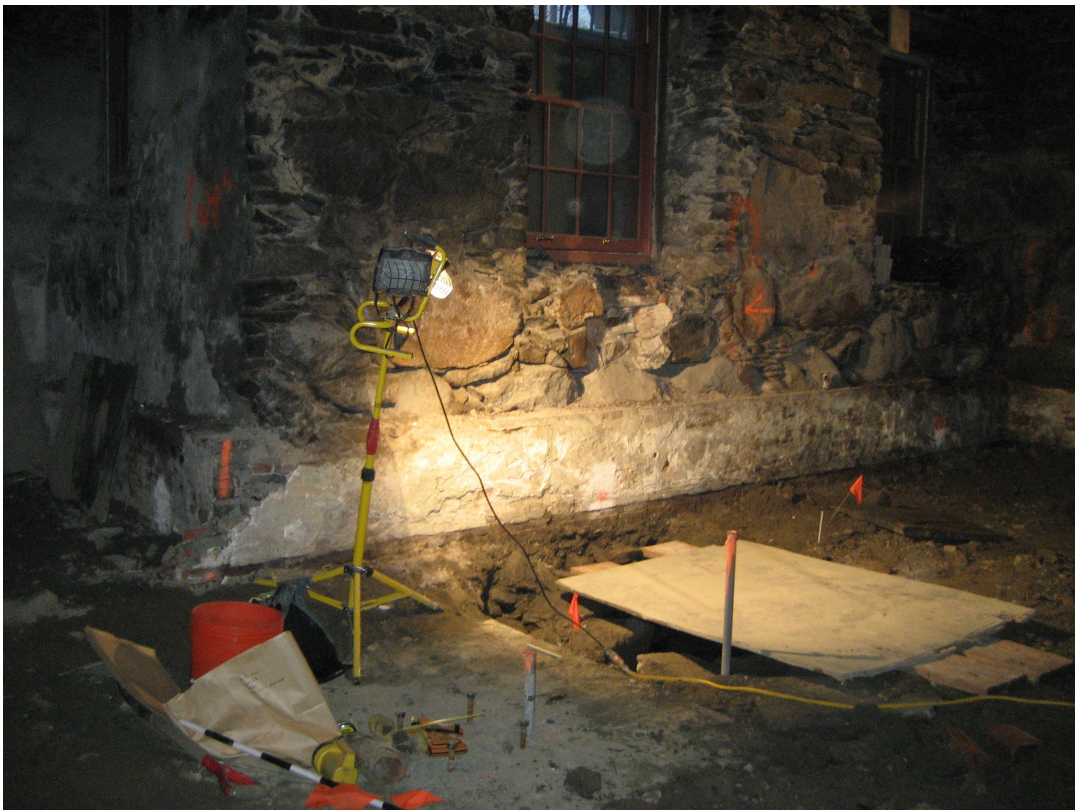
After the stone caps and the drainage pipes were mapped, exploration of the western edge of the well began to seek the relationship between the well feature and the west wall foundation of the building. There appeared to be three levels of construction for the foundation wall (See Figure 6 and Figure 7). The lowest level was a layer of stone rubble which seemed to be the base or underlying structure for the foundation wall. This layer appeared to be 20cm/8" deep and filled with medium size stones that were loose in the soil. The rubble level had some voids of soil between stones. Then large flat stones with mortar were placed on top of the rubble to complete the wall up to the height of the building's ceiling. The third layer was a level of brick, which served as additional wall material. The brick wall appeared to be a later addition as it also started on the stone rubble, but was built parallel to the large flat stones and created an interior ledge at its top. The brick wall's height measured to 66cm/26" and continued as an addition to the lower portion of the foundation wall throughout the entire building.

Figure 6. View of the three textures of the foundation wall: flat stones, brick, and stone rubble.

The well feature was lower in depth relative to bottom of the solid brick foundation wall. As the rubble stones continued downward from the brick wall, the well stones emerged as being under and apart of that rubble construction for the foundation wall (See Figure 6). With this stratigraphic relationship, there is archaeological evidence that the well was built on this property before Rhode Island Hall was erected.

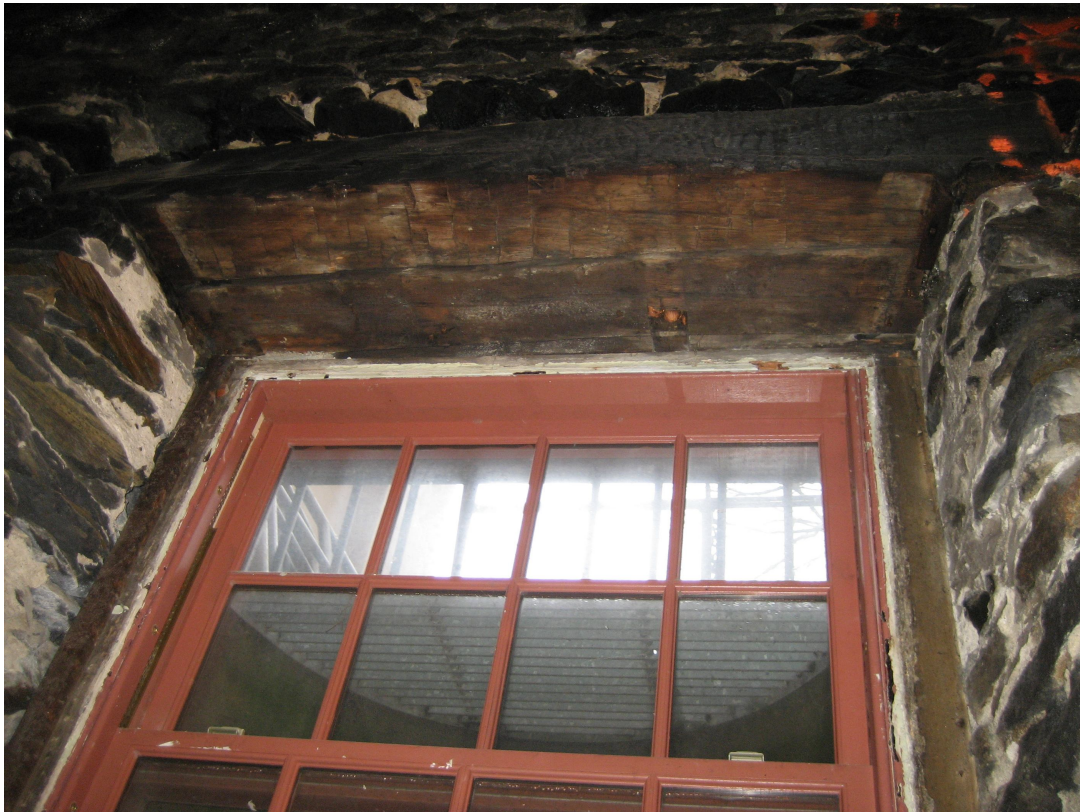
Within the stone foundation wall was an intact window which can be used as reference point and will hopefully be a guide to relocating the well feature in the future. The location of this window was already described above and several characteristics were observed during the survey. The window is approximately 115cm/45" wide and 173cm/68" in height. There is a trapezoid shaped casement or sill for the window with the widest side being along the east or interior of the foundation wall. This casement created a window ledge that is 50cm/20" deep into the stone wall. From the top of this ledge, the well is located 160cm/63" below the window sill and 20cm/10" east of the foundation wall. Above the top of the window casement are two large, charred, square, wooden beams placed parallel that serve as supports for the window opening within the wall (See Figure 8). These beams were approximately 10cm/4" thick and 127cm/50" long.

Figure 8. View of the wooden beams above the window supporting the casement in addition to a visual of the ground surface to the exterior of the building.

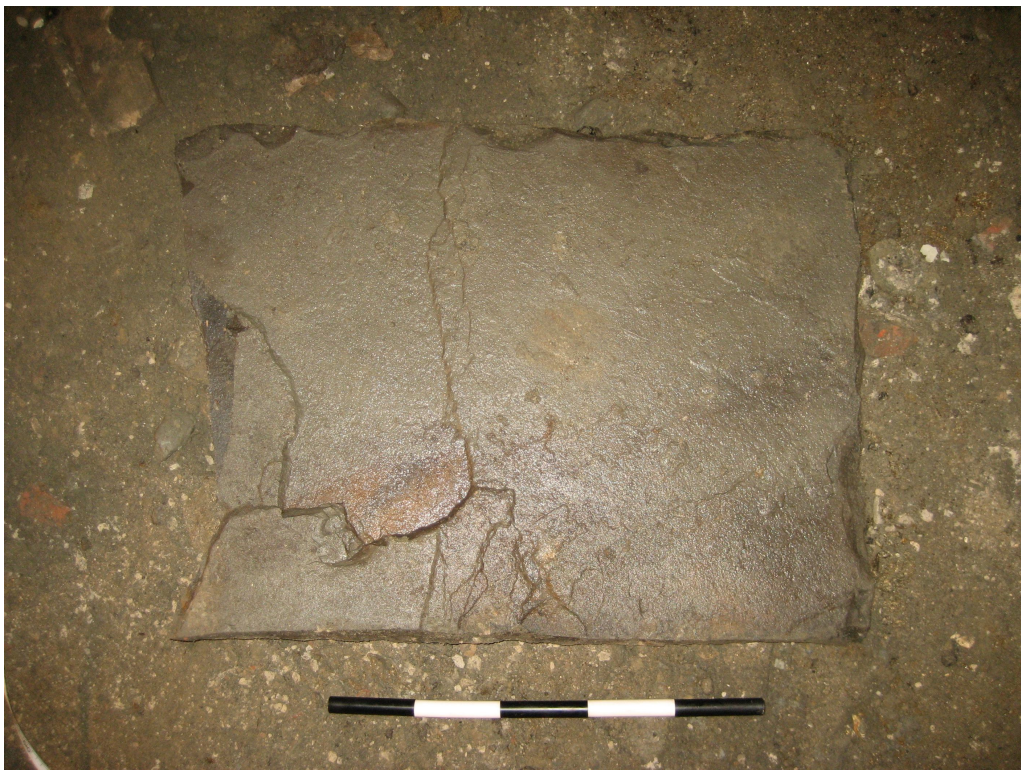
After the investigation of the foundation wall association, the stone caps covering the well were removed in order to examine, record, and measure the exact dimensions of the well. The three large flat sections of stone caps already described above were lifted off and placed to the side of the well (See Figure 9).

Figure 9. View of one of the removed stone caps that covered the well.

There were no apparent traces of mortar between the caps and the well stones. The sheer weight of the stones and the 5cm/2” layer of mortar that was found on top of the caps were likely enough to hold them in place. The layer of mortar discovered on top of the stone caps could be

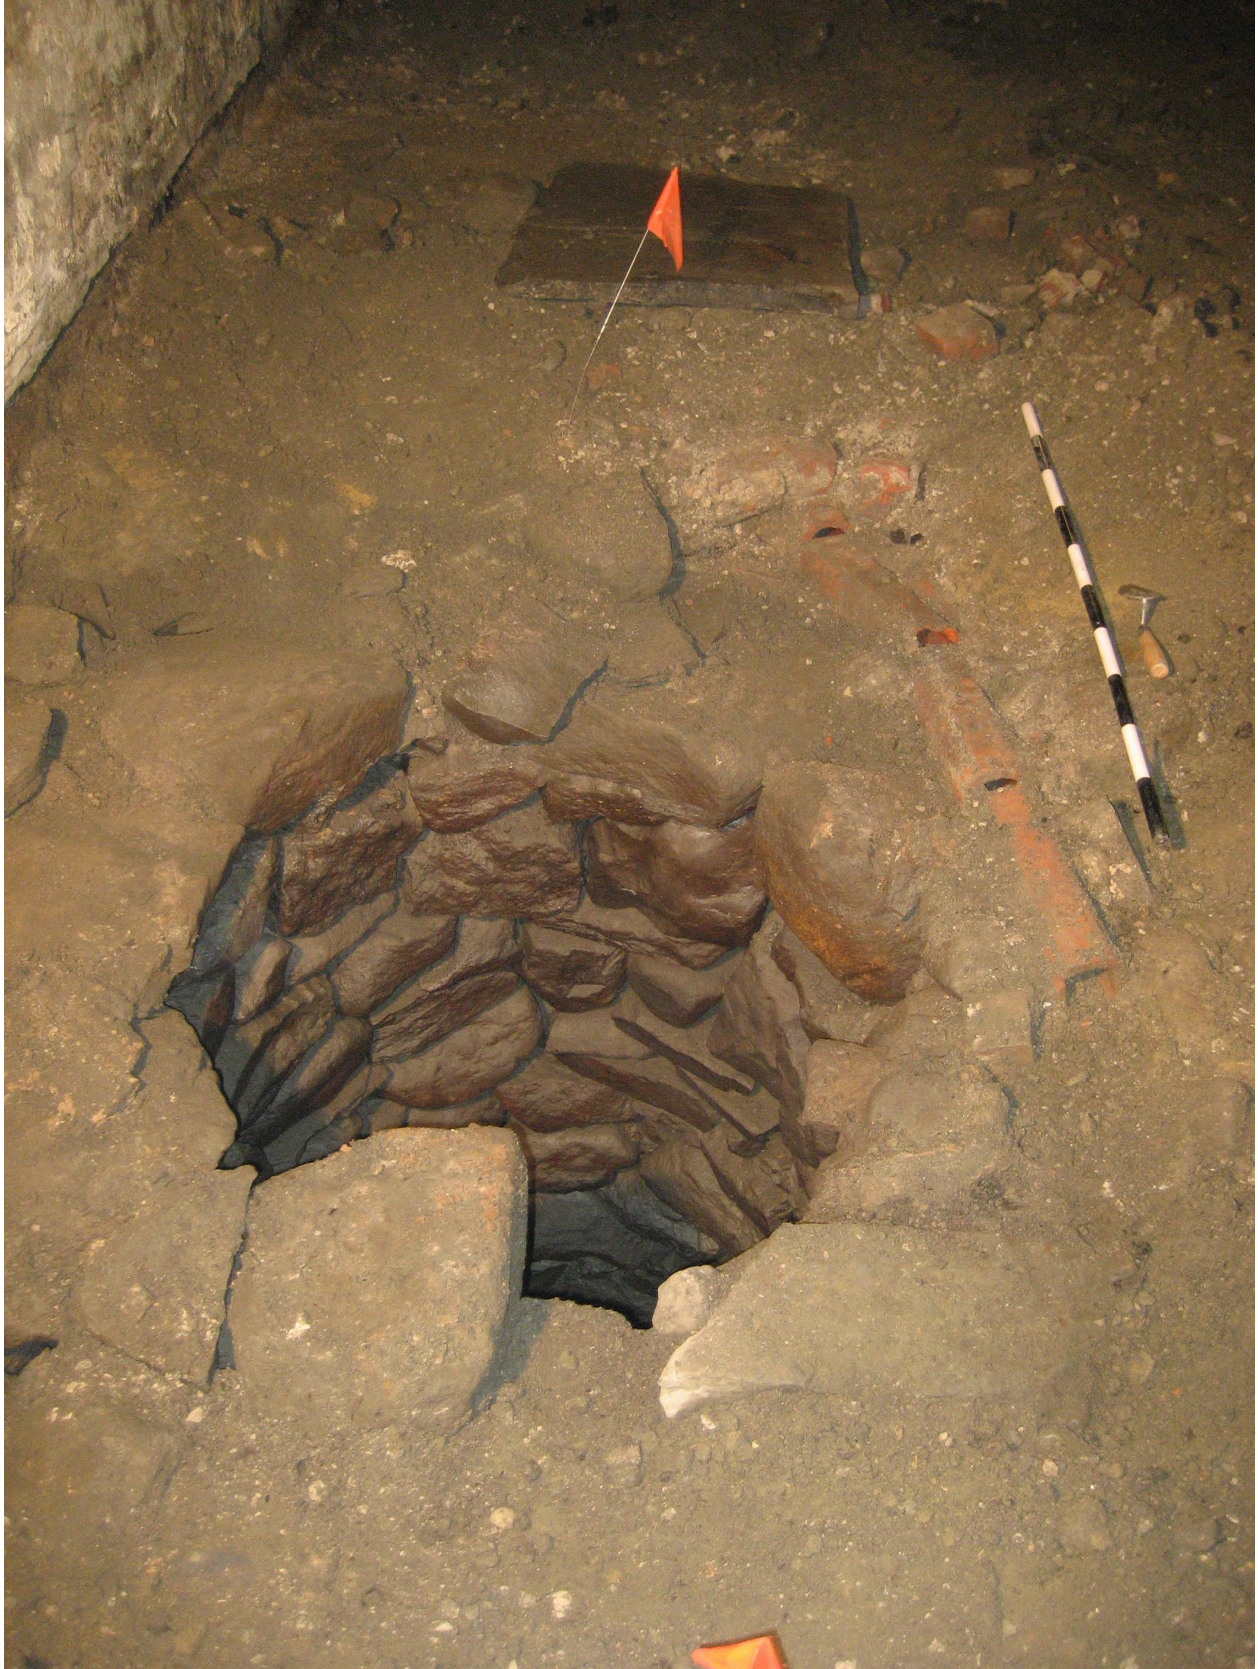
attributed to the convenience of covering the well during the construction of the Hall as such a large and intact feature would be difficult to remove. Some trowel work cleared the remaining soil around the well to fully expose all the stones that lined the feature (See Figure 10). One additional drainage pipe segment was discovered in this process and increased the total number of pipe sections to four (See Figure 11). All of these pipes measured 33cm/13" long, 10cm/4" wide, and 9cm/3½" in height with an oval shaped opening that was 7cm/3" by 6cm/2½" in circumference.

Figure 10. View of the uncapped and exposed well.

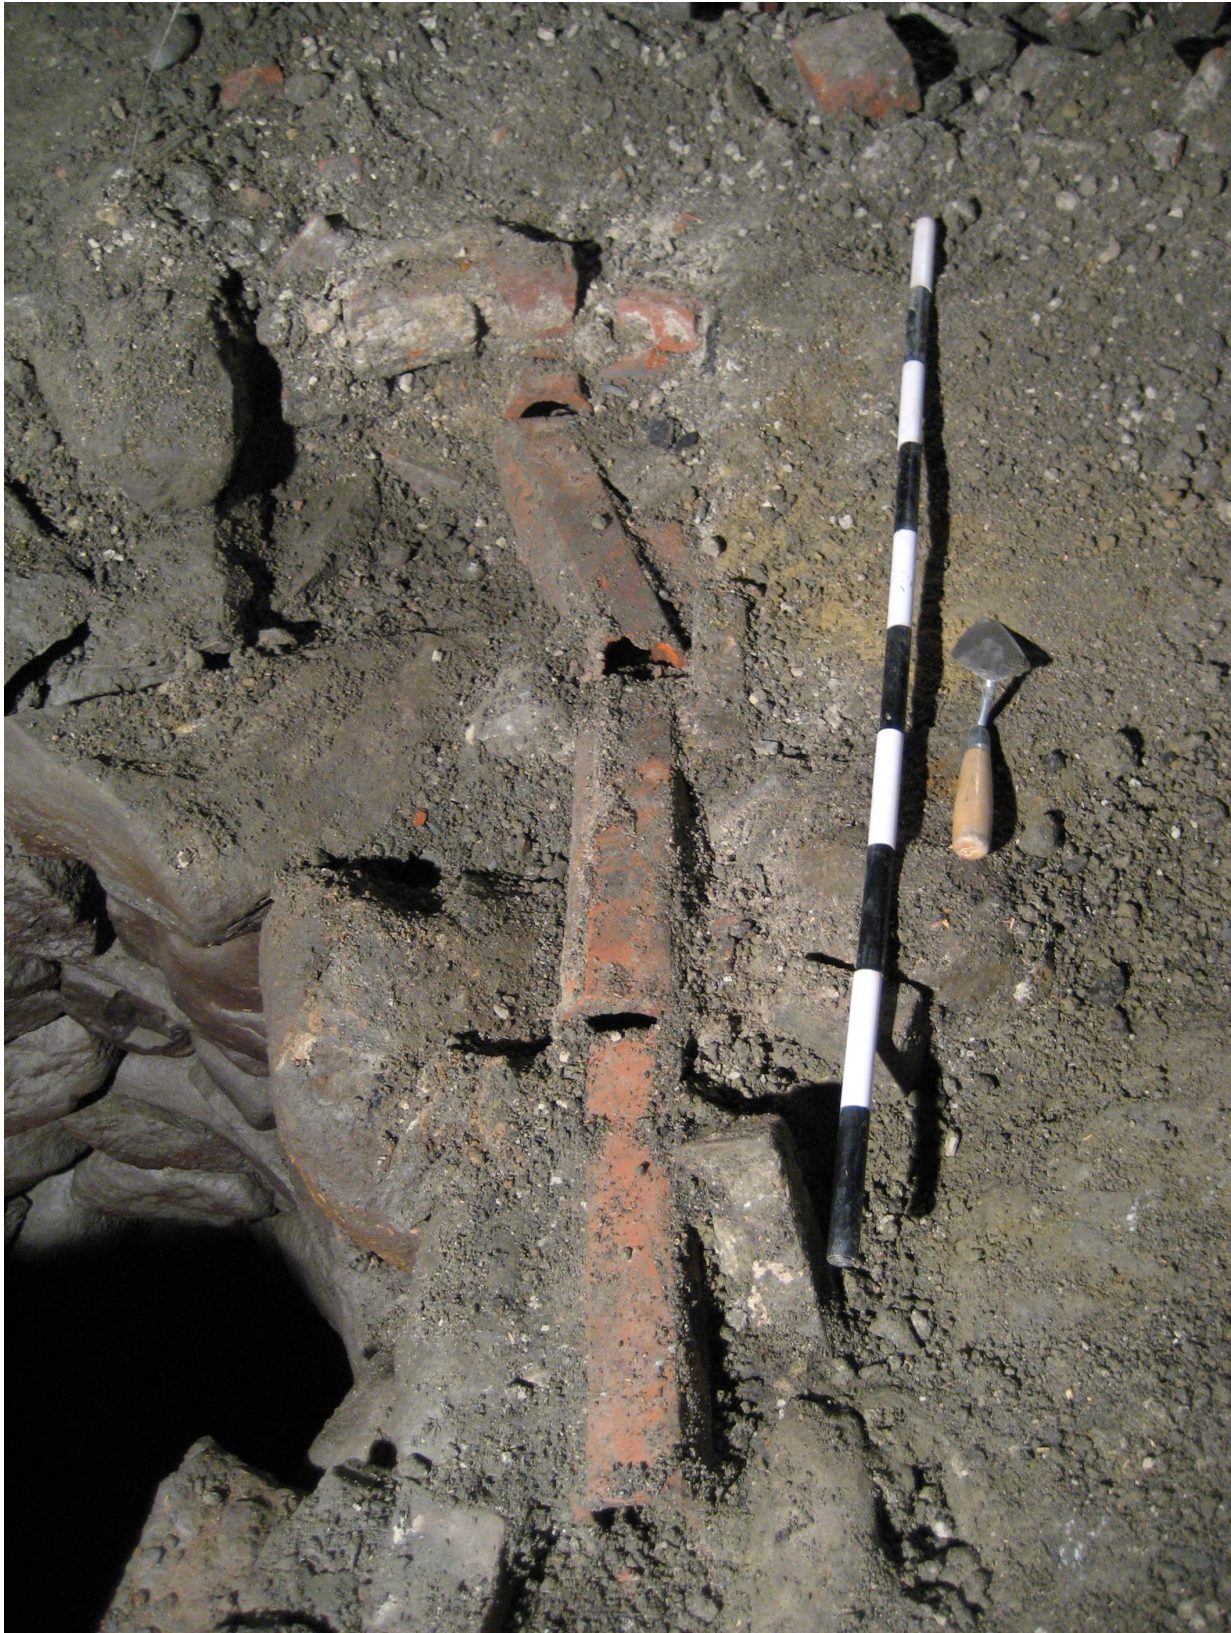
Figure 11. View of the further exposed terracotta drainage pipe system. Note the brick supports along pipes edges.

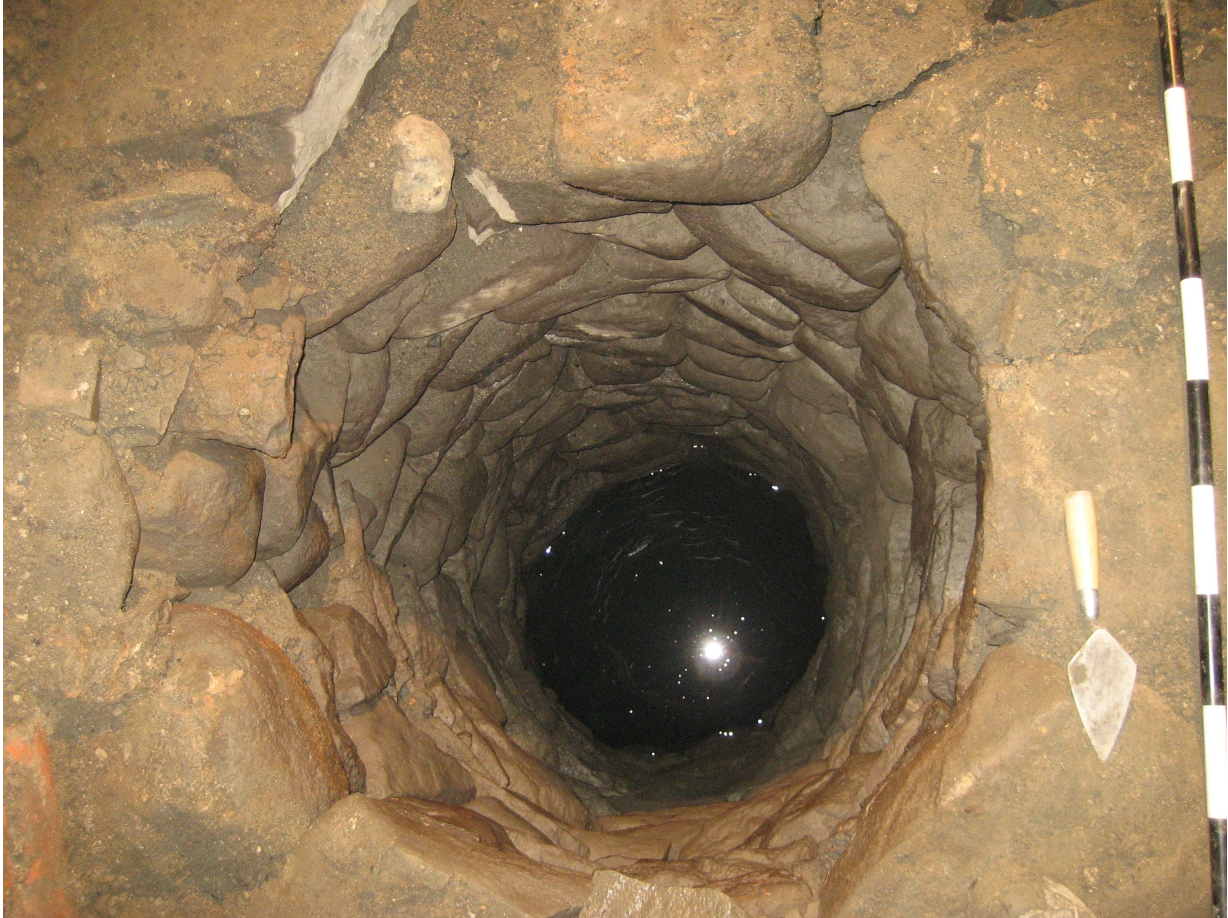
The circular shaft well constructed of large unmortared stones was intriguing. The stone type used for the well was undetermined. The interior shaft was 80cm/32" in diameter. From the surface stones to the bottom of the well, its depth reached an approximate 7m/24'. There was an estimated 4m/14' of water in the well, which left around 3m/10' of exposed stones lining the feature up to the surface (See Figure 12).

Figure 12. View of the depth of the well, its unmortared stone lining, and water filled bottom.

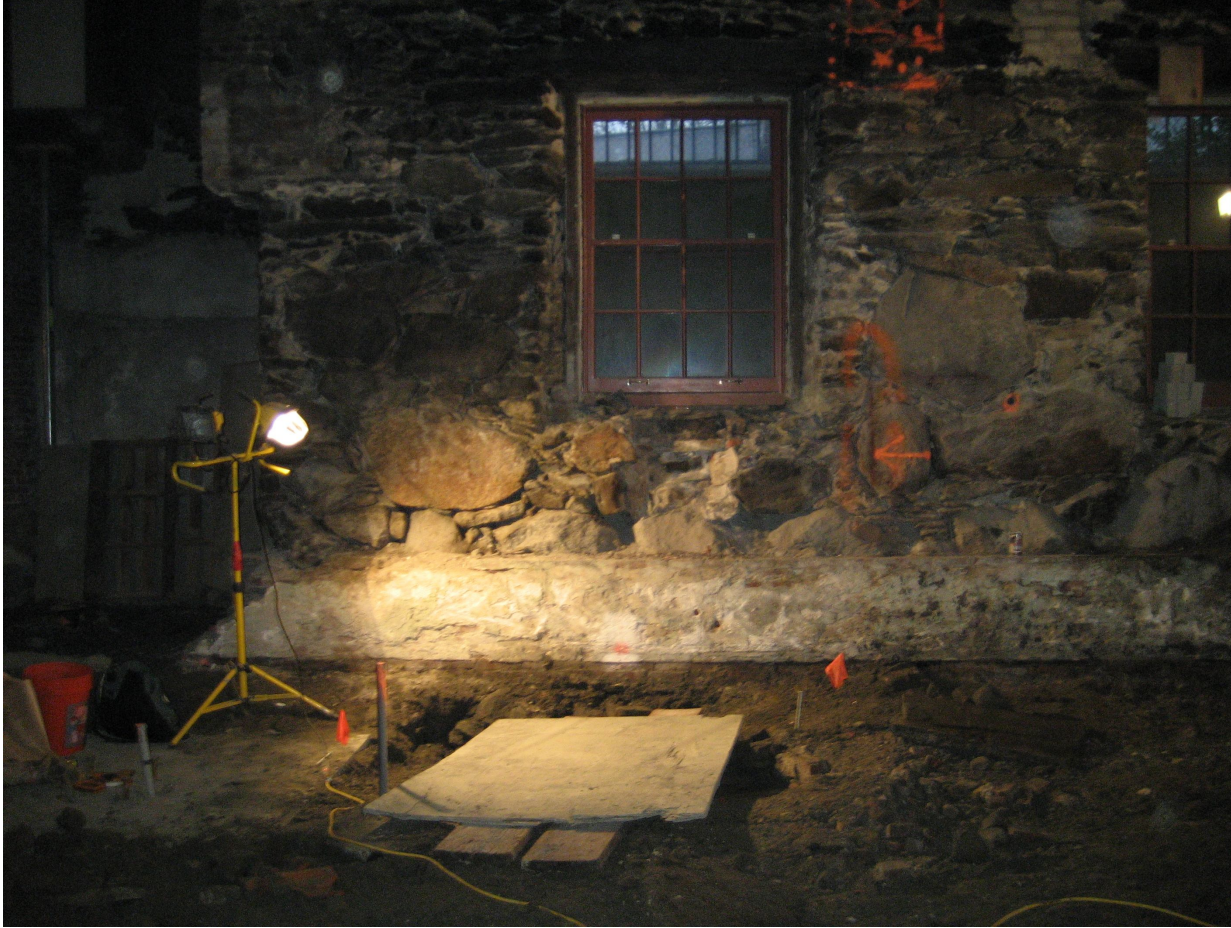
There were eleven stones that composed the top rim of the well, which were all similar in shape and size. Only four of these were drawn on Map 2 before the open hole had to be covered in order to comply with site safety regulations (See Figures 13 and 14). This point marked the end of the fieldwork.

Figure 14. Western facing view of the survey area with the well boarded over.
